Performance study over the use of reinforced flexible pavement with steel mesh at Brazilian road

R. M. Fortes & J. V. Merighi

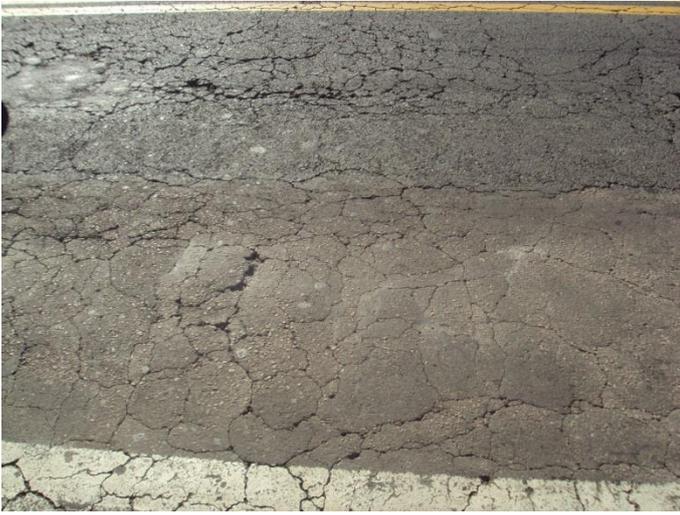
In the segment of the test section to restore solution to be adopted was a reprofiling polymer thickness of 20 mm along with a DST (Double Surface Treatment) with another polymer layer CAP (Asphalt Cement) in thickness of 40 mm. On November 23, 2012, a revisit to the highway was made and found the presence of a much deteriorated pavement, with the presence of crocodile crack and wear track. Figure 1 shows the situation of the pavement.

Figure 1. SP354 view of the pavement in the presence of 100% defect "crocodile crack".

The asphalt coating pans features, patches, areas with surface wear and curl in alternating segments of the pavement. In some segments found there was almost complete deterioration of the pavement structure, with localized areas of consolidation presenting sags in places and trails runs, sags and swells on the trails and local plastic wheel well of broken interlocking type FC-3 form “alligator”.

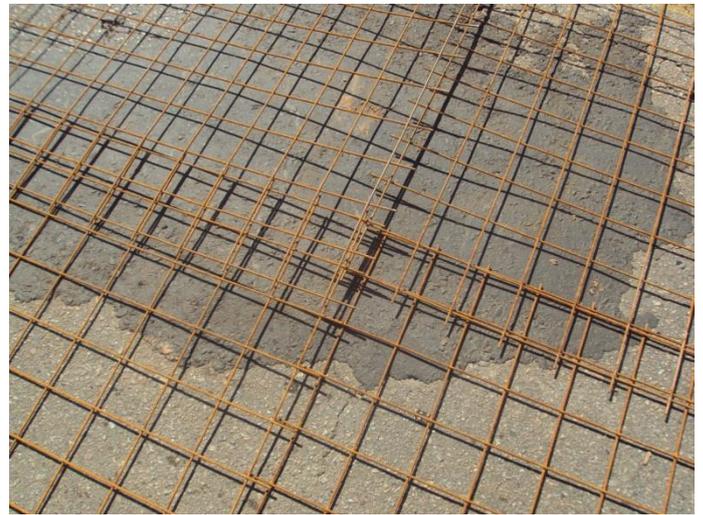
In the case of transversal splices, the spliced wires should also be in the same plane. Services of cutting and mooring shall be executed at the construction site. Figure 2 shows the lateral splices and the detail of the overlapping meshes. This overlapping must be avoided because it was observed that the pathologies (potholes) occurred in the coating, where the welded mesh was overlaid, resulting in a thickness of more than 3 wires.

Figure 2. Detail of overlapping meshes.

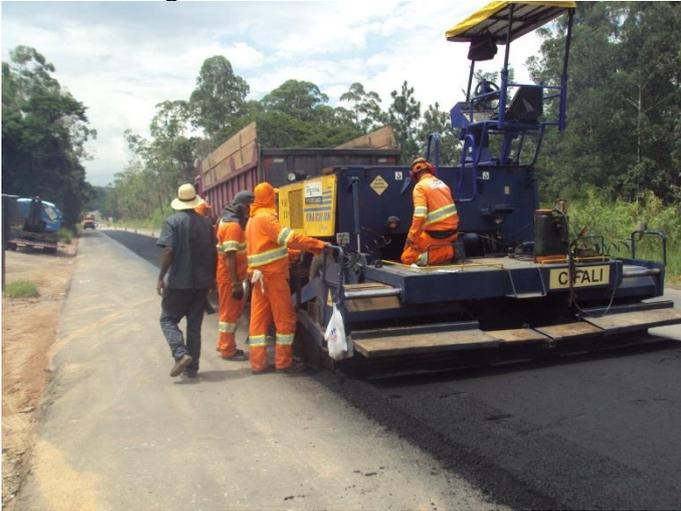
It should be noted that half of the runway (to Jarinu – Campo Limpo Paulista) a recapping was applied using the Q138 welded mesh in interface between the existing pavement. It was completely “crocodile cracked”, with potholes in the coating layer, and only the placement of the mesh was done, applying binder painting on the placed and fixed mesh, and repaving with asphalt concrete graded “III” of DER-SP as can be seen in Figure 3.

Figure 3. Repaving applied using asphaltic concrete.

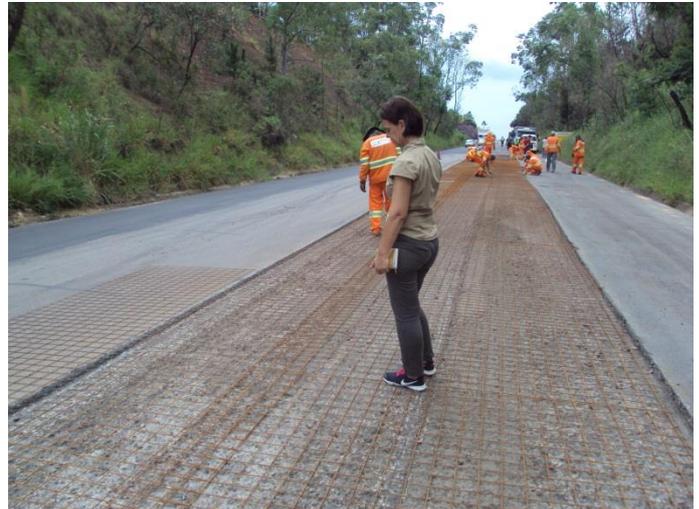
The overlapping in the longitudinal direction was also increased (Figure 4), which became to be one mesh. In addition, there was an improvement in setting, and attention on trimming the meshes, in the corners, where overlapping occurred on all meshes, so it would have an overlap of at least two wires.

Figure 4. Repaving over the executed mesh.

The next day, it was observed that increasing the overlap of the meshes in a longitudinal direction, had a lower performance than in the first part, where there was no such overlap, because transversal cracks appeared, with thickness larger than was presented in the previous part.

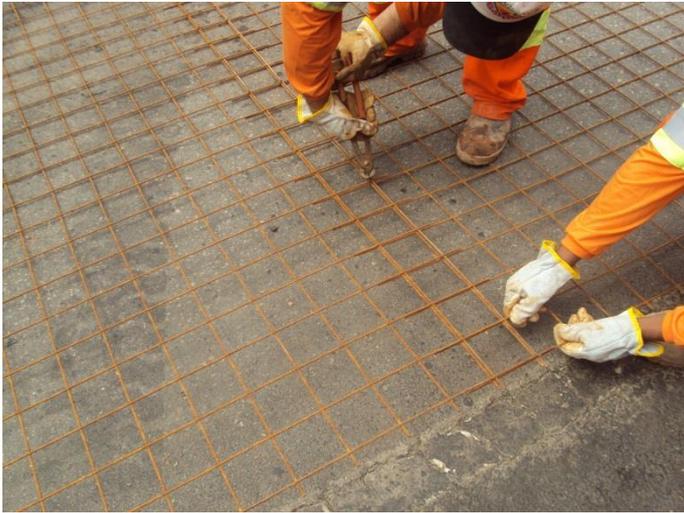
This caution tries to reduce the thickness of the meshes when placing avoiding the overlapping. The coatings on the longitudinal direction, was done as in the first part without any meshes overlays. In addition, there was an improvement in setting using 5mm steel bars, driven into the milled pavement. There was

also careful to cut the corners of meshes where overlapping occurred on all meshes so that there was overlap of at least two wires.

Figure 5. Fixation of the steel mesh.

On the following day of the execution, it was not observed the appearance of cracks, which leads to the idea that the fact the meshes have been placed “confined”, since it was placed on the milled pavement, the movement has been reduced contributing to not generate cracks. Thus, it is concluded that besides the problem of overlapping meshes, the fixation is of paramount importance.

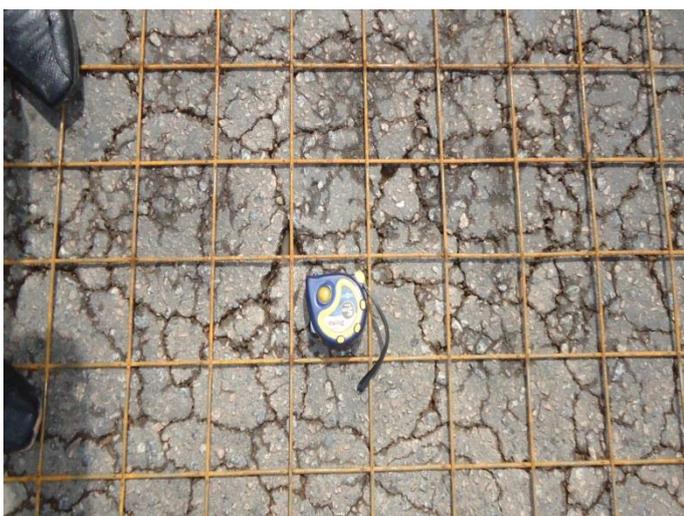
The fourth part was held on 13.03.2013, from stake 547+07 to stake 551+04. In this excerpt steel welded meshes on the existing pavement were settled, which appeared with a high presence of sags and “crocodile cracks” (Figure 6). The difference between the execution process from the preceding part to this one in order to lessen or even “cure” the problem of appearance of transversal cracks was essentially the removal of cross bars of the first grid, increasing fringe (removal of the peripheral wire, transversal to the direction of traffic).

Figure 6. “Crocodile cracks” on existing pavement.
